September 6, 2012

ECS Project # 03-216630.00

Re: Response to Questions- Risk Based Site Cleanup and Disposal Plan
Thomas Prince School
170 Sterling Road
Princeton, MA 01541

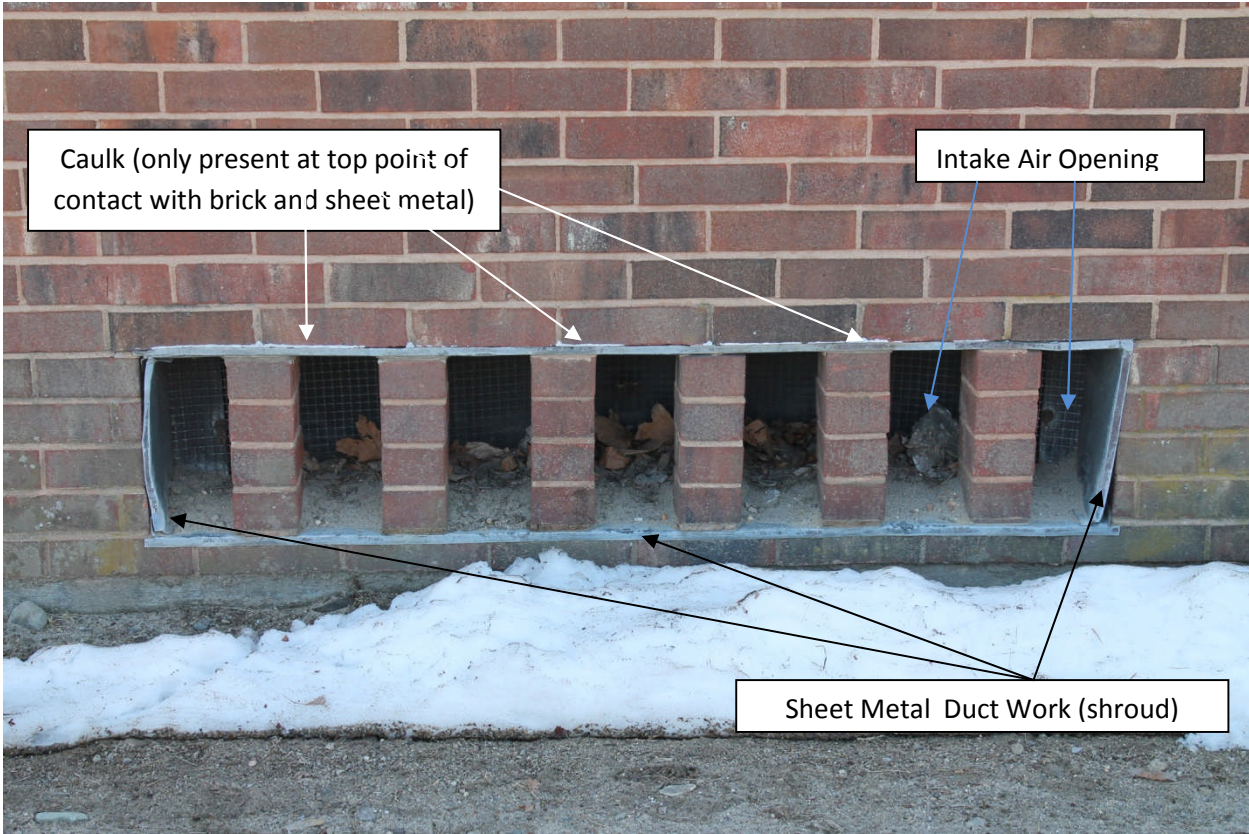
Air Intake Vents – 100 Wing Classrooms – Prior to and following the meeting which I attended at the school yesterday, ECS and TEI closely inspected the air intake vents for the subject 100-Wing classrooms. See the attached photo, Figure 1, for a depiction of a typical vent for the subject 100-Wing Classrooms.

A typical vent opening is 54 inches wide by 8 inches in height. It is located on the bottom vertical side of the building and does not contain a louvered plate over its front but rather is open in the front, divided by several, eight inch high by two inch wide brick columns. Sheet metal ducting lines the interior of the vent and is supported in the front opening by the brick columns. The sheet metal ducting extends contiguously into the unit ventilator. Where it comes in contact with the exterior brick face of the building facade, it is crimped at a 90° angle to overlap the exterior building brick face by approximately ½ inch on all four sides. It was determined that caulking is only present at the top of the ducting of each exterior vent opening where the sheet metal duct work comes in contact with the brick, i.e. the side and

bottom joints do not contain caulk and no remnants of caulk were observed. The unit ventilator draws its room dilution air from this vent opening.

Figure 1: Typical Exterior Vent Structure: 100 Wing Classrooms.

Following is the plan, in order of operation, to address these exterior vent openings as part of the previously submitted modification.

- 1) All exterior caulk associated with the vents will be removed (this will be approximately 22.5 linear feet based on caulk only being present at the top of the vent as recently confirmed);

- 2) The ½ inch of sheet metal that is crimped at a 90° angle parallel with the brick face, on all four sides, will be bent back so that it is perpendicular to the brick face. This will provide access to the small gap between the brick and the sheet metal for cleaning and epoxy coating;

- 3) The gaps between the sheet metal and brick will be suctioned with a HEPA vacuum to remove loose residual debris that may be present;
- 4) The readily accessible inner surfaces of the duct work, at and within the opening of the air vent, will be cleaned via HEPA vacuum to remove dust, dirt or debris;

- 5) The readily accessible surfaces of the sheet metal duct work and brick that were in contact with the caulking will be cleaned via wet wipe methods;

- 6) The readily accessible inner surfaces of the duct work, at and within the opening of the air vent, will be cleaned via wet wipe methods;
- 7) Two coats of epoxy will be applied to the accessible surfaces of the brick to a distance of eight inches (four brick widths) from each side of the vent, consistent with the previously approved distance for the 200-Wing rooms). In addition, two coats of epoxy will be applied to the brick surfaces that are perpendicular to the brick face wall at a distance of approximately ½ to 1 inch at the corners of the brick surface that extend below the metal duct work;

- 8) The edges of the sheet metal duct work, adjacent to the exterior brick building façade, will be bent back to their original positions such that approximately ½ inch of sheet metal will cover the edges of the epoxy coated brick at the openings of the air vents.

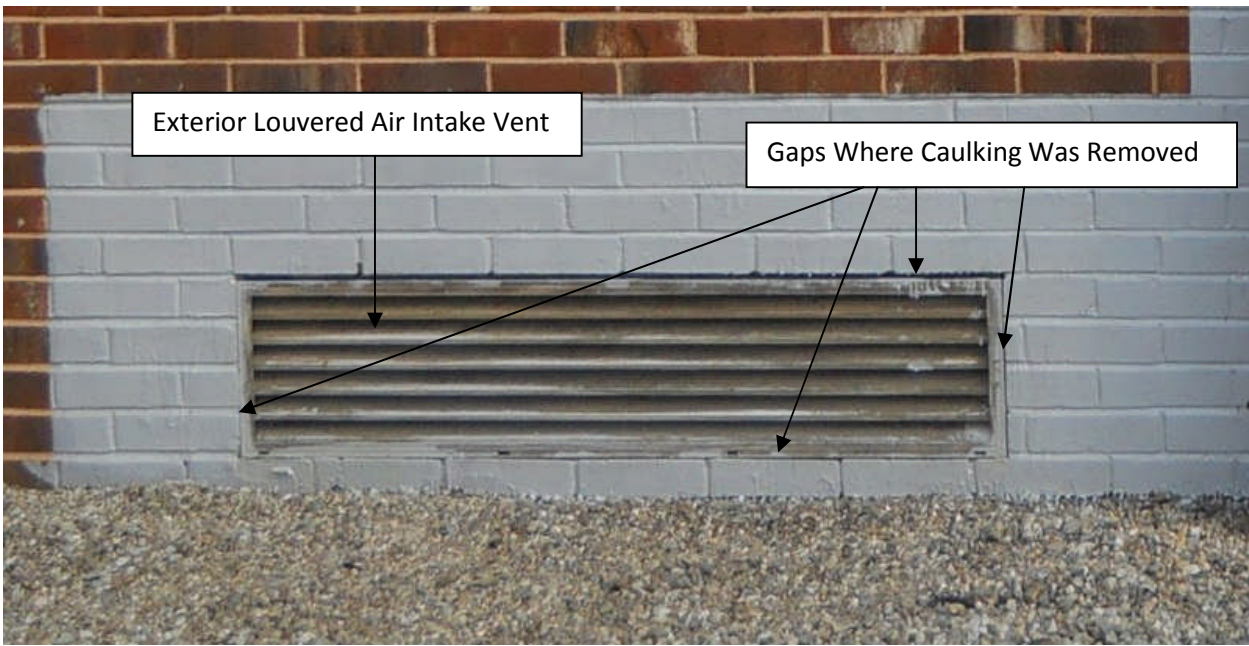
Air Intake Louvered Vent Covers – 200 Wing Classrooms – As we discussed on Tuesday, the approved Risk Based Site Cleanup Plan for the 200-Wing exterior metal louvered air intake vent covers provided for the removal and replacement of the covers (section 4.4, bullet one of the February 13, 2012 Risk Based Cleanup Plan). Due to an oversight, the vent covers were not removed. Following the meeting at the school yesterday, ECS and TEI closely inspected several of the exterior louvered air intake vent covers for the 200-Wing classrooms. Review of field notes and a discussion with the TEI Field Supervisor were also performed to confirm the actions that were taken to address the metal louvered vent covers. Based on a review of available information and discussions with TEI, it was confirmed that the following actions were taken in response to the exterior louvered vent covers:

- a) All visual exterior caulking was removed;
- b) The outer sides of the louvered vent covers (sides facing away from the building) had been cleaned via HEPA vacuum and wet wipe methods (the inner sides of the vent covers (facing the building) had not been cleaned);

- c) Two layers of epoxy were applied to the brick face within 8 inches of each side of the louvered vent covers.

Figure 2: Typical Exterior Louvered Vent Structure: 200 Wing Classrooms.

As a modification to the plan, ECS proposes to collect three wipe samples, per required EPA methodology, and submit the samples for analysis via EPA Methods 3540C and 8082 for PCB's. It is proposed that one sample each be collected from three of the six existing inner sides of the louvered vent covers. If the result of a wipe sample for a particular louvered vent cover is greater than 1 ug/100cm² PCB, that louvered vent cover will be removed and cleaned via HEPA vacuum and wet wipe methods or replaced with a new cover.

If the cleaning option is selected, upon cleaning, another wipe sample will be collected from the inner side of the vent. If the sample result remains greater than 1 ug/100cm² PCB, the louvered vent cover will again be cleaned via HEPA vacuum and wet wipe methods or replaced with a new cover. Any cover that produces results less than 1 ug/100cm² PCB will remain in place or be reinstalled (if it was removed for cleaning and re-sampling). This procedure will continue until either a result of less than 1 ug/100cm² PCB is obtained for a particular vent cover or until a new cover is obtained. The decision to resample or replace a cover will be made by the Town of Princeton. See the attached photo, Figure 2, for a depiction of a typical exterior louvered vent cover for the 200-Wing Classrooms.
